Lake Narracan Precinct Structure Plan Area

DESKTOP ENVIRONMENTAL, HYDROLOGICAL AND GEOTECHNICAL ASSESSMENTS

Final V1 | June 2013

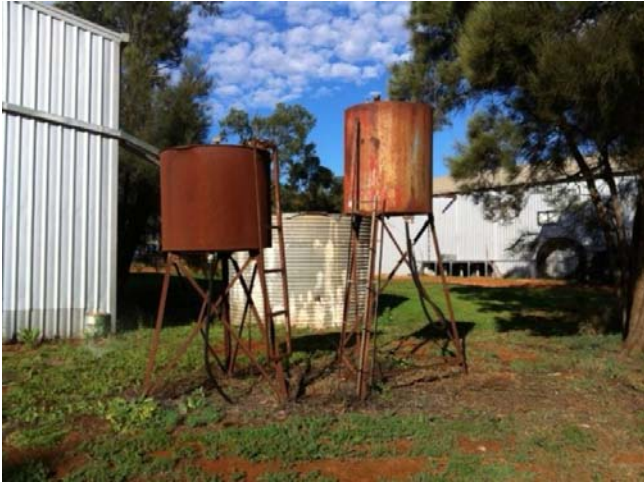
Plate 7.1 : Example of above ground storage tank

Storage shed construction can vary depending on their age and can be variously formed of timber, corrugated iron, asbestos cement sheeting, blocks/bricks and concrete. Some sheds may also incorporate concrete floor slabs while others do not.

Based on the above, the most likely sources of contamination include spillages of fuels as well as impacts on soils by metals resulting from general machinery/equipment storage and maintenance of farm vehicles. However, spillages of other agricultural chemicals may also impact upon soils. Given that such chemicals are typically stored in small volumes (less than 20L) impacts are therefore likely to be extremely localised in extent. Additional contaminants of concern can also include biological contaminants and nutrients associated with leakages from septic tank systems.

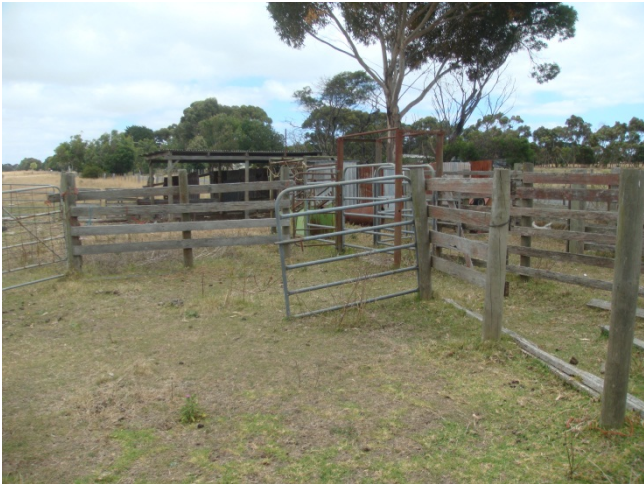
Plate 7.3 : Example of a stockyard structure

Stockyard structures were frequently noted within the PSP study areas. These are used to hold livestock prior to loading on to trucks. They are typically timber enclosures, sometimes including a small covered shed for storage.

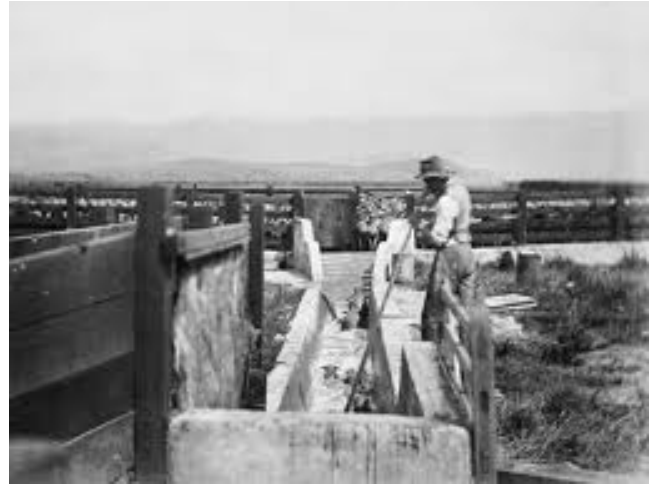
Plate 7.4 : Example of typical sheep dip

It should be noted that no sheep dips were observed during the site inspections. However, a number of properties could not be visually assessed to confirm their absence. It should also be noted that the absence of a dedicated in-situ sheep dip does not rule out such an activity taking place at a stockyard. Metals troughs are also used as a mobile alternative.

Contamination of soil and groundwater can result from the above activities as the liquid formulation either leaks from defects in the dipping infrastructure (be it a permanent sheep dip or mobile trough) or drains from sheep while they are retained in the holding enclosures after dipping is completed.
