Information sheet for environmental audits and preliminary risk screen assessments (PRSAs)

Victoria's audit system

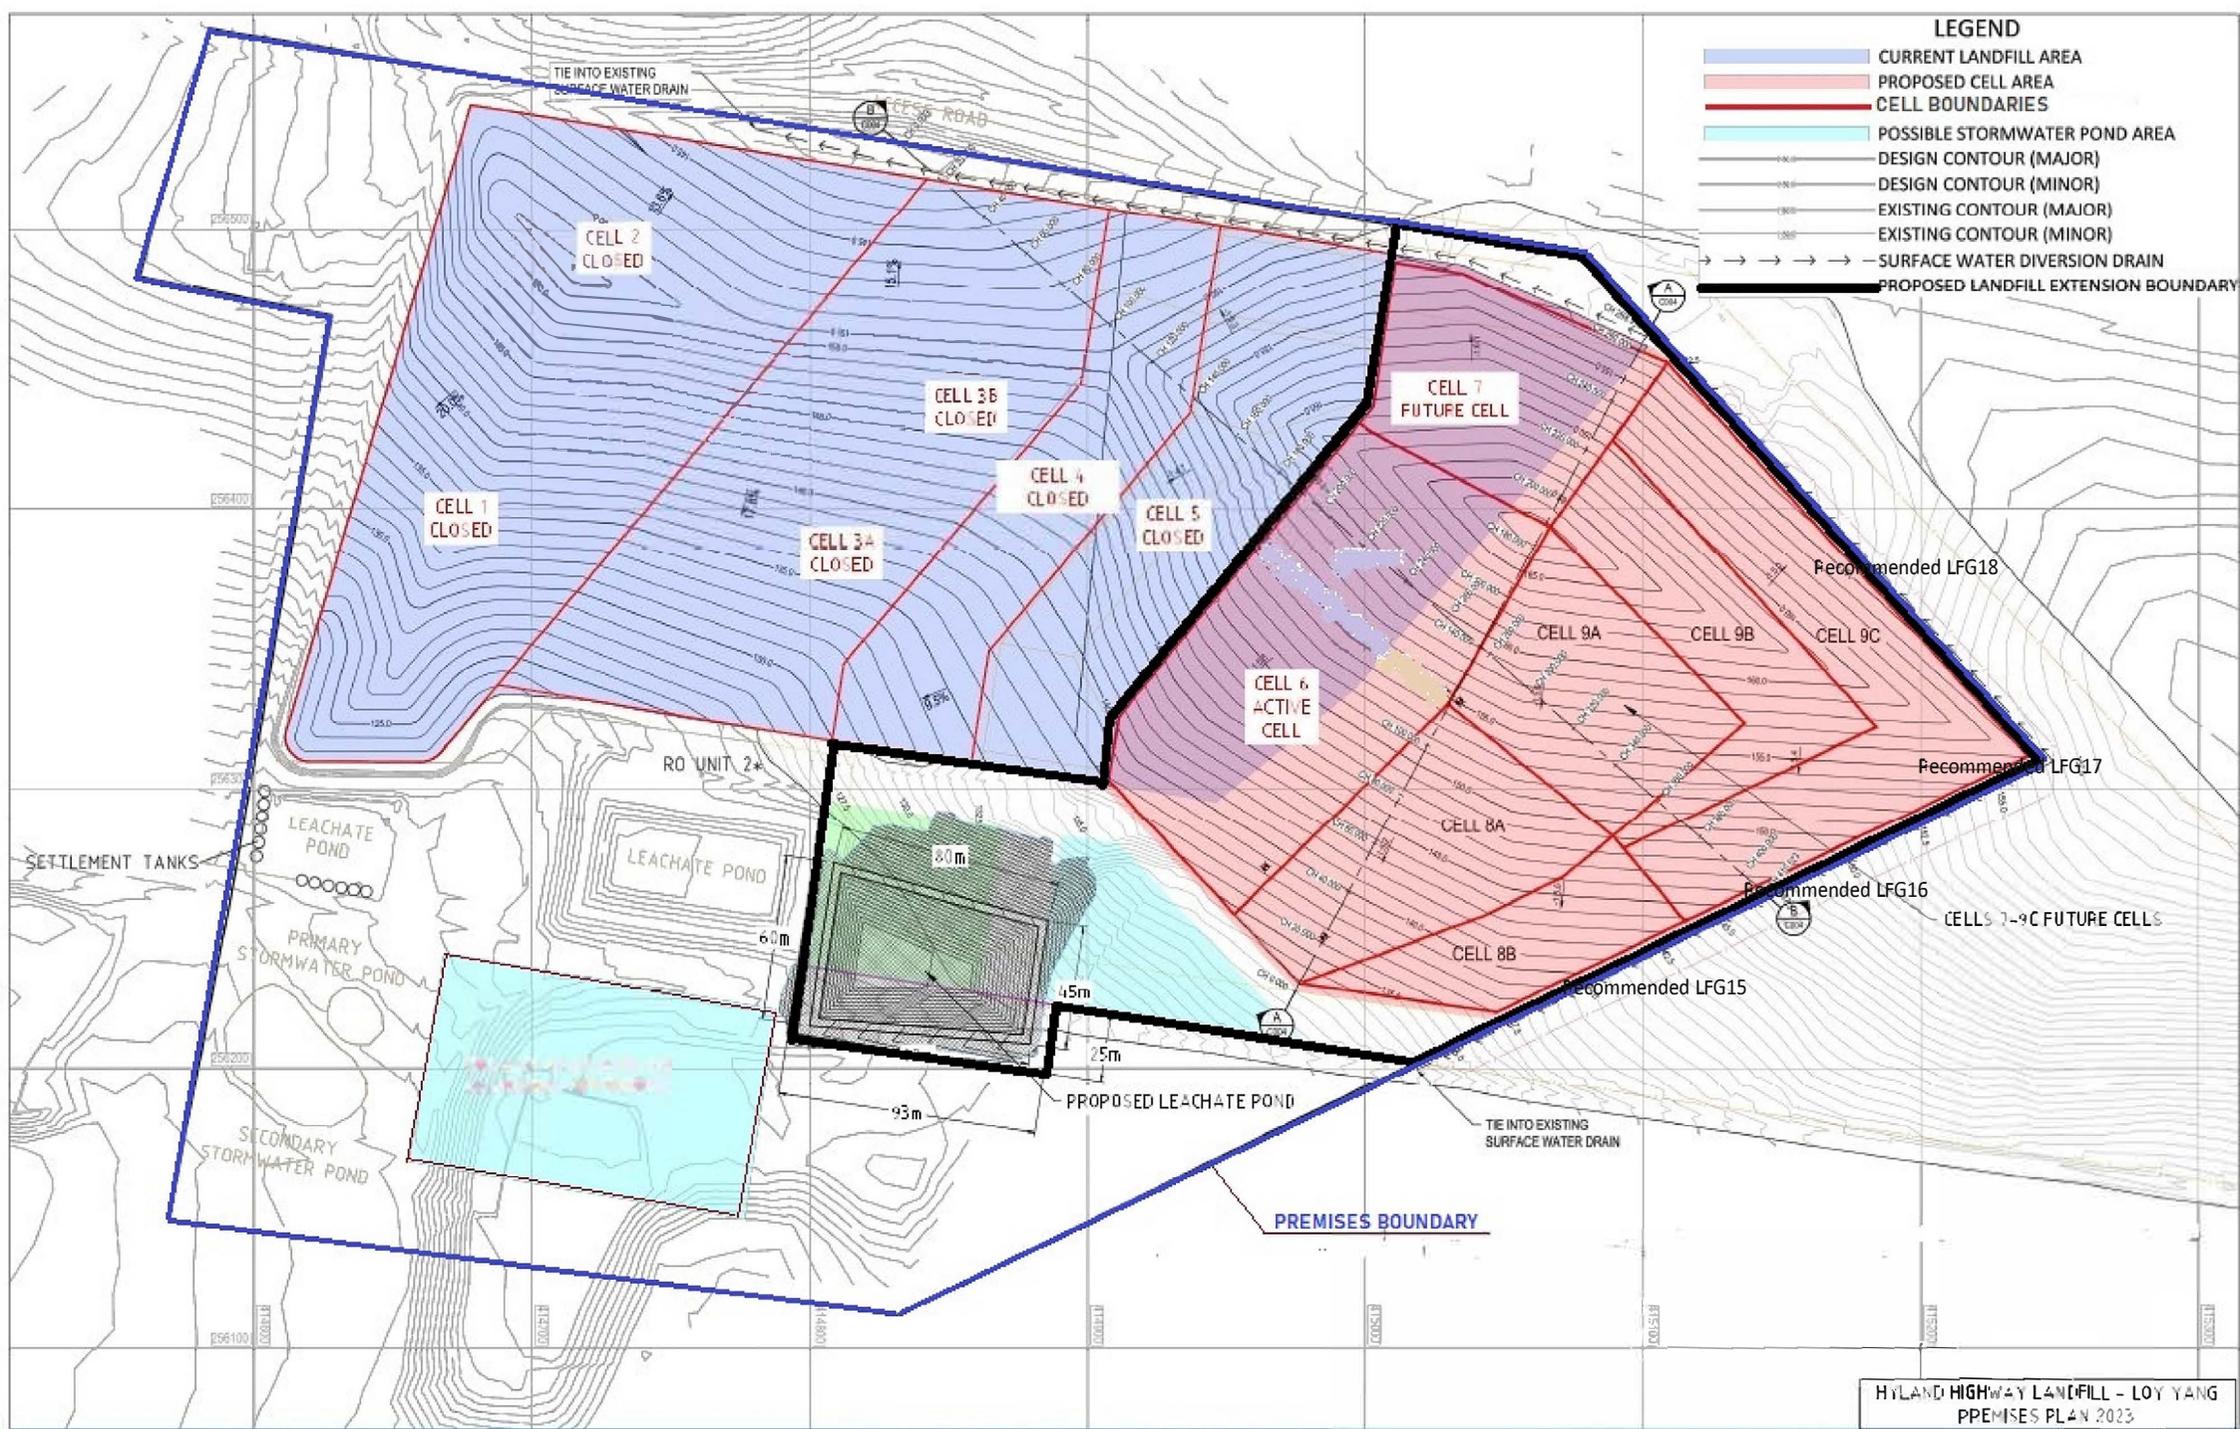
- CURRENT LANDFILL AREA
- PROPOSED CELL AREA
- CELL BOUNDARIES
- POSSIBLE STORMWATER POND AREA
- DESIGN CONTOUR (MAJOR)
- DESIGN CONTOUR (MINOR)
- EXISTING CONTOUR (MAJOR)
- EXISTING CONTOUR (MINOR)
- SURFACE WATER DIVERSION DRAIN
- PROPOSED LANDFILL EXTENSION BOUNDARY

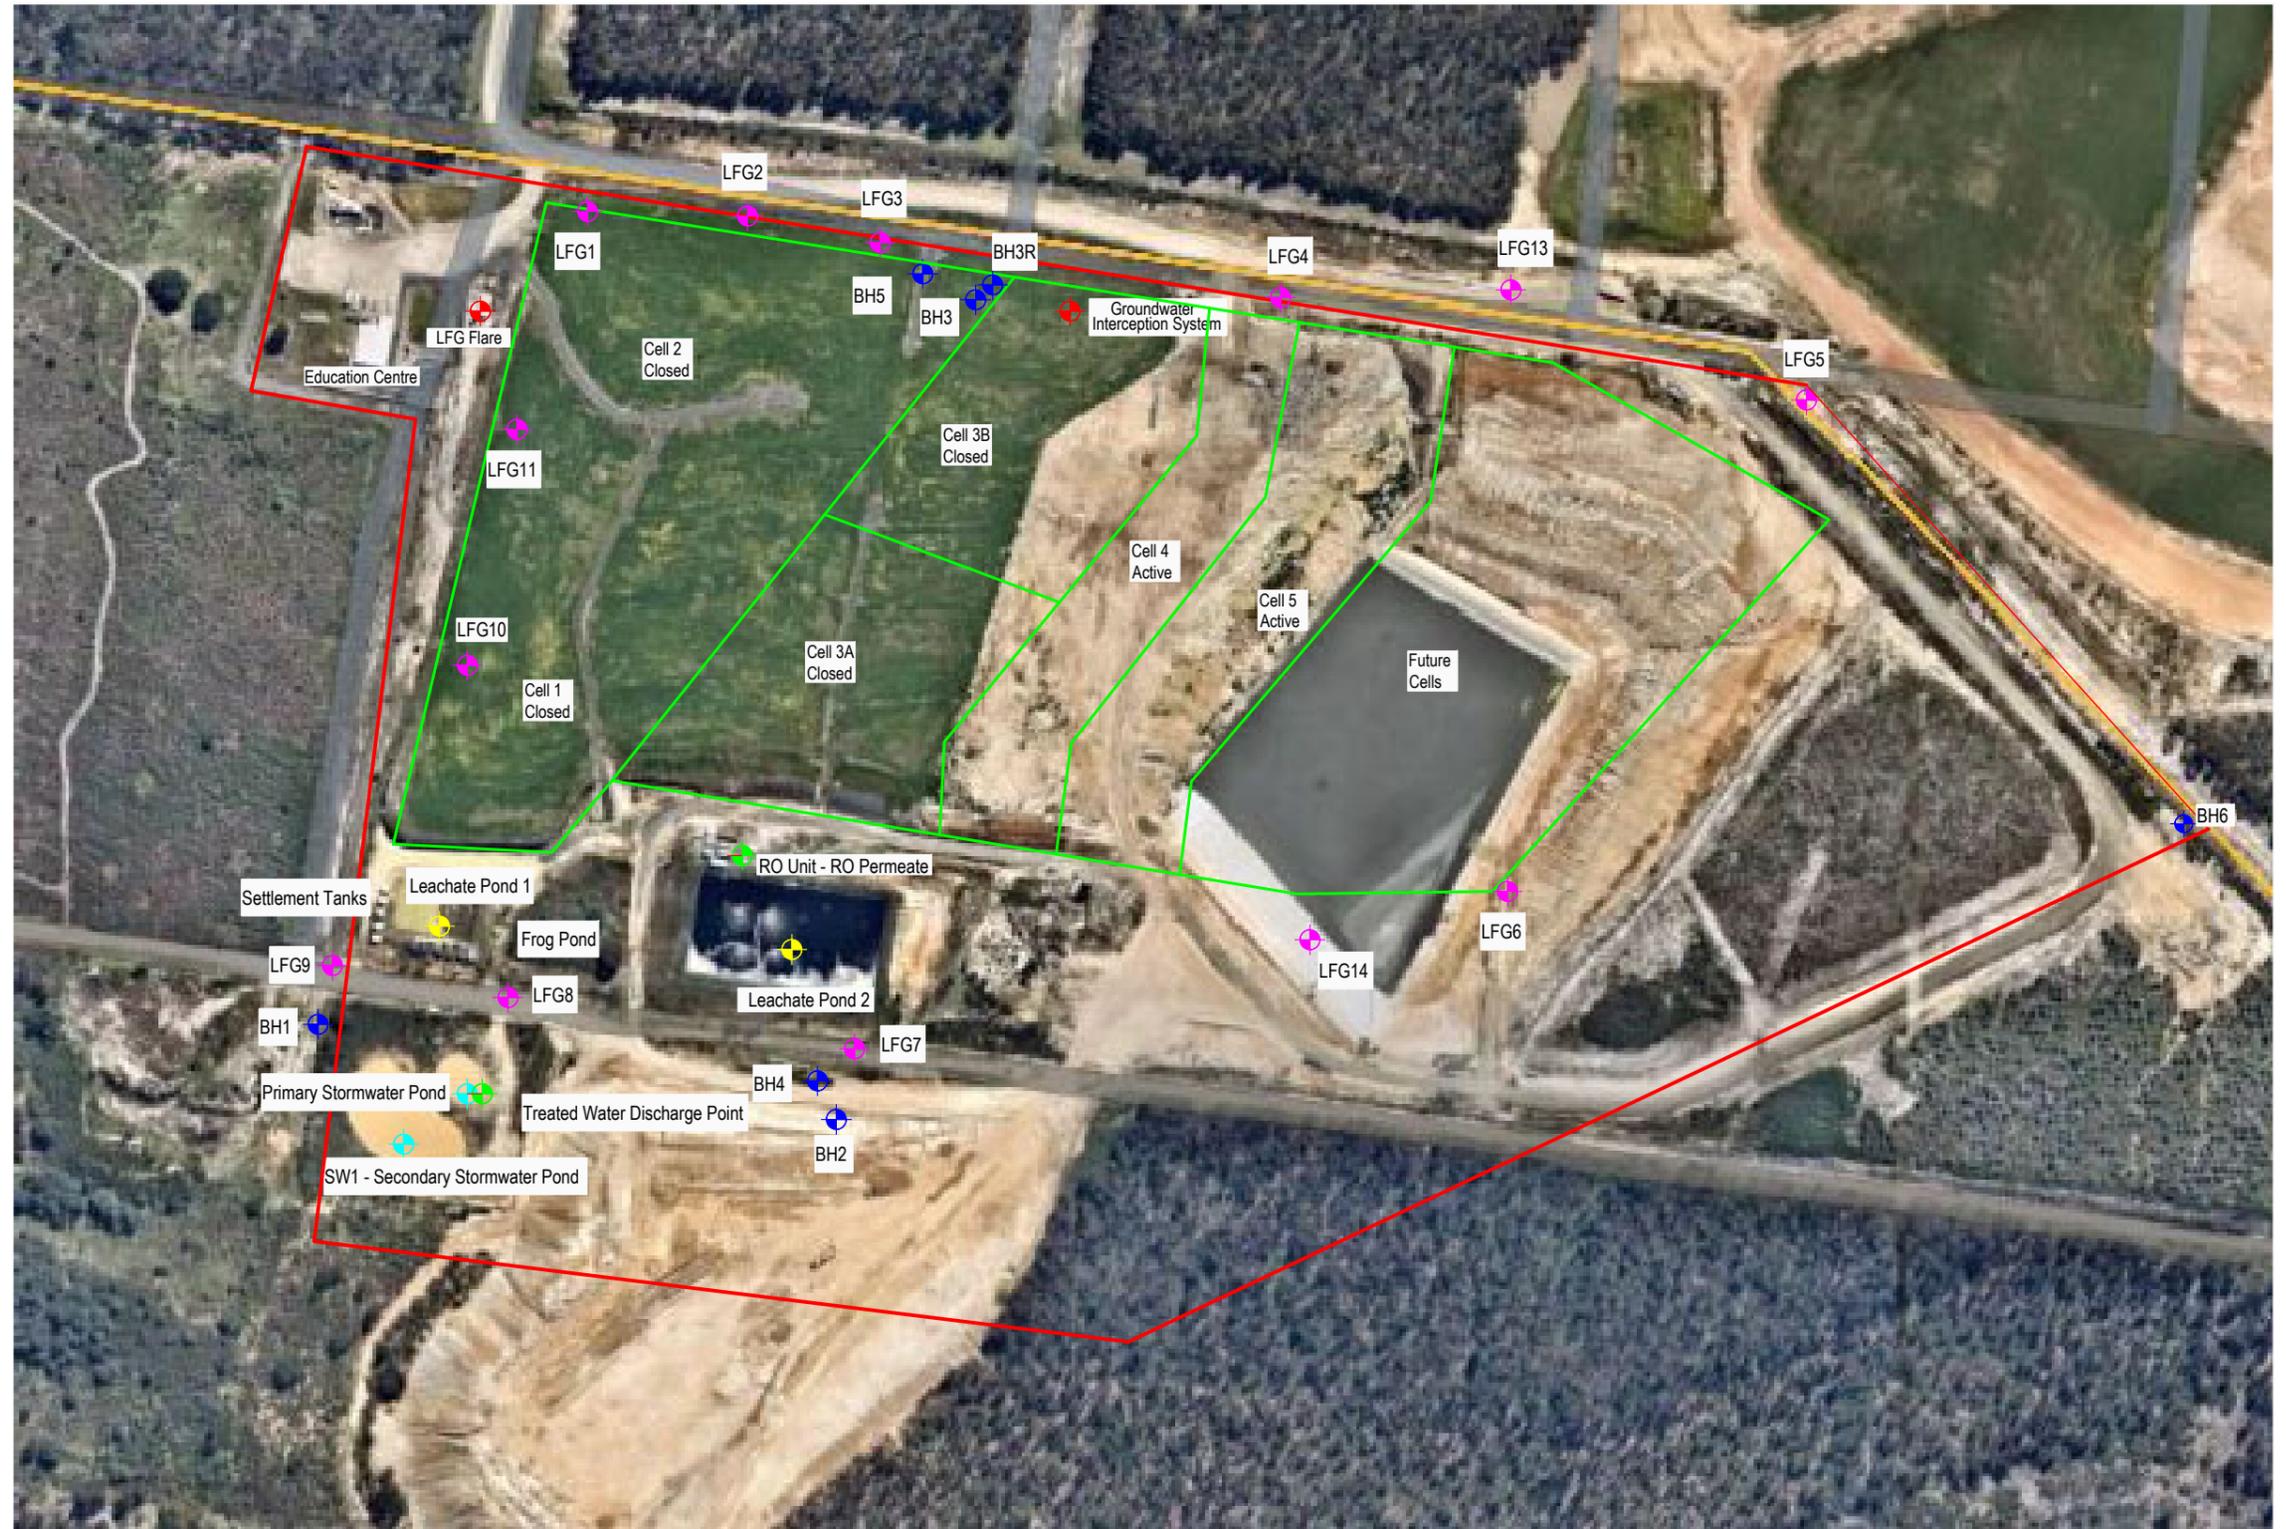
SITE	64 Hyland Highway, Loy Yang, VIC
TITLE	Site Monitoring Locations - Figure 3

- Landfill Premises Boundary
- ◆ - Groundwater Monitoring Well
- ◆ - Surface Water Monitoring Point
- ◆ - Reverse Osmosis Permeate Point
- ◆ - Leachate Pond Monitoring Point
- ◆ - Groundwater Interception System Monitoring Point
- ◆ - Landfill Gas Bore Monitoring Bore

Note: Aerial photo taken from NearMap Satellite Image: 19 October 2022

The locations of these bores are shown in Figure 3 and their depth, screened interval, top of casing level and lithology are summarised in Table 6-1.

The locations of these existing LFG monitoring bores are presented in Figure 3.

LCC partitioned the remnant Swampy Riparian Woodland from the landfill. As shown in Figure 3, this area is termed the frog pond.

The locations of the RO plant and SW1 are shown on Figure 3. The locations of the two Traralgon Creek monitoring sites are shown on Figure 4.

The locations of the two leachate are shown on Figure 3.

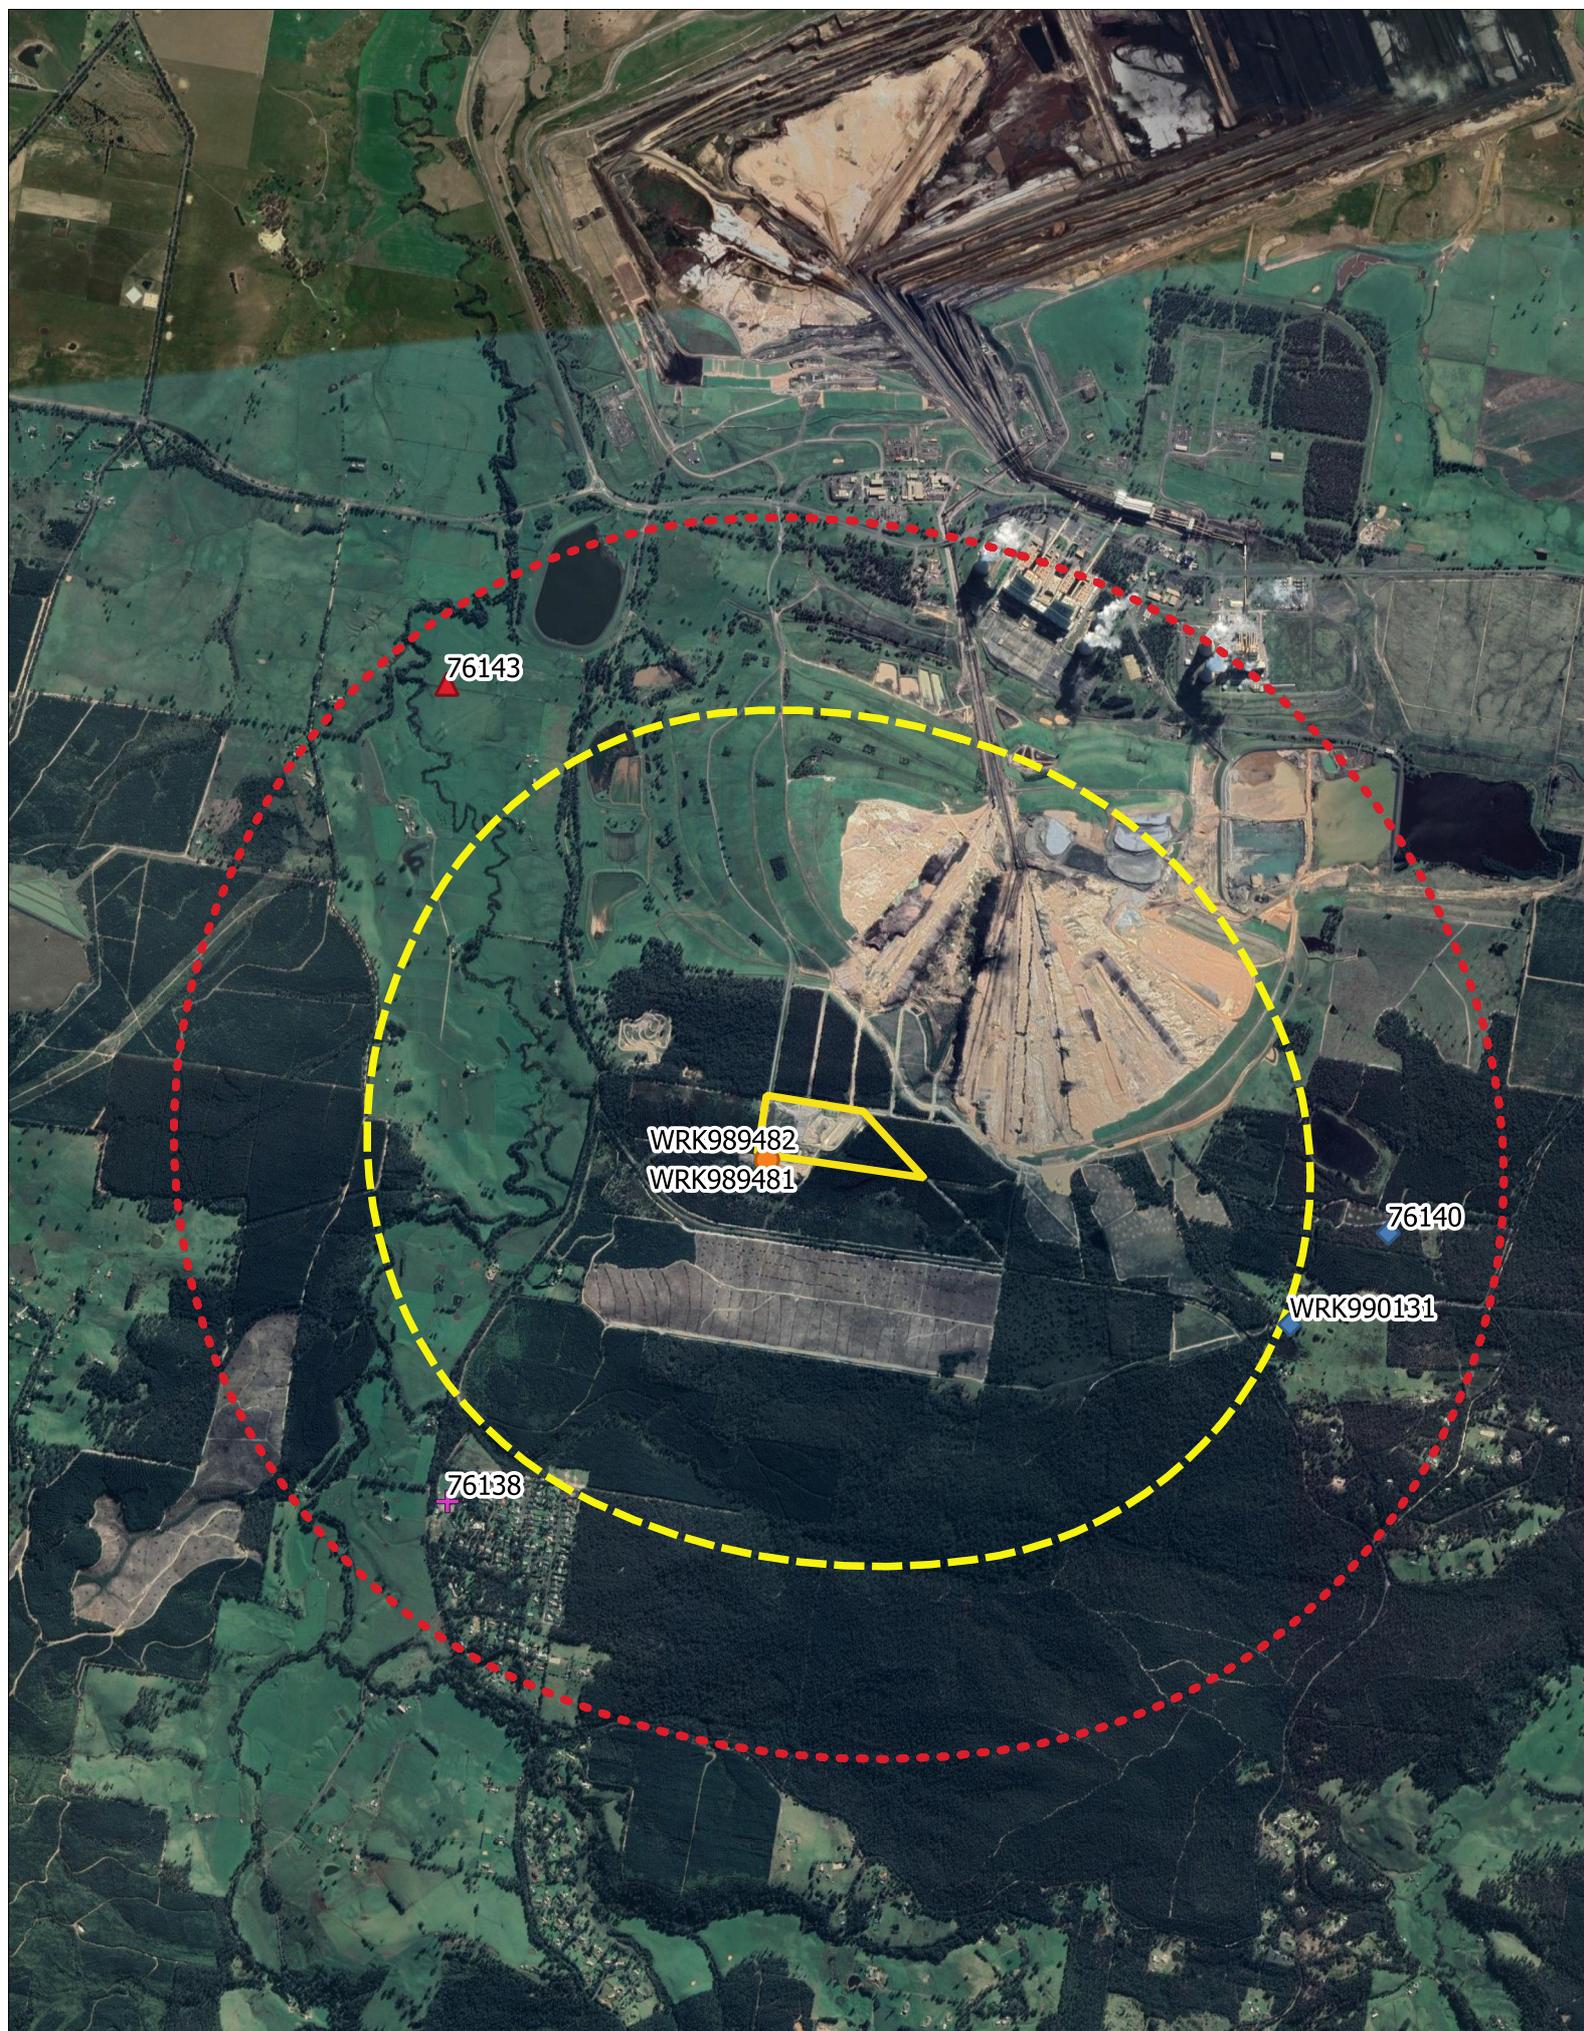
FIGURE: Loy Yang - WMIS surrounding bore survey

- Site outline
- Boundary radius 2km
- Boundary radius 3km
- ▲ STOCK
- ◆ DOMESTIC AND STOCK
- + URBAN
- GROUNDWATER INVESTIGATION

The *Water Measurement Information System* was interrogated in August 2023 for registered groundwater bore data within 3 km of the site. This search excluded SECV exploration bores. Table 5-3 lists the information obtained from the six bores identified in this search. This finding was confirmed by BEC (2023). The location of these bores are shown in Figure 5.

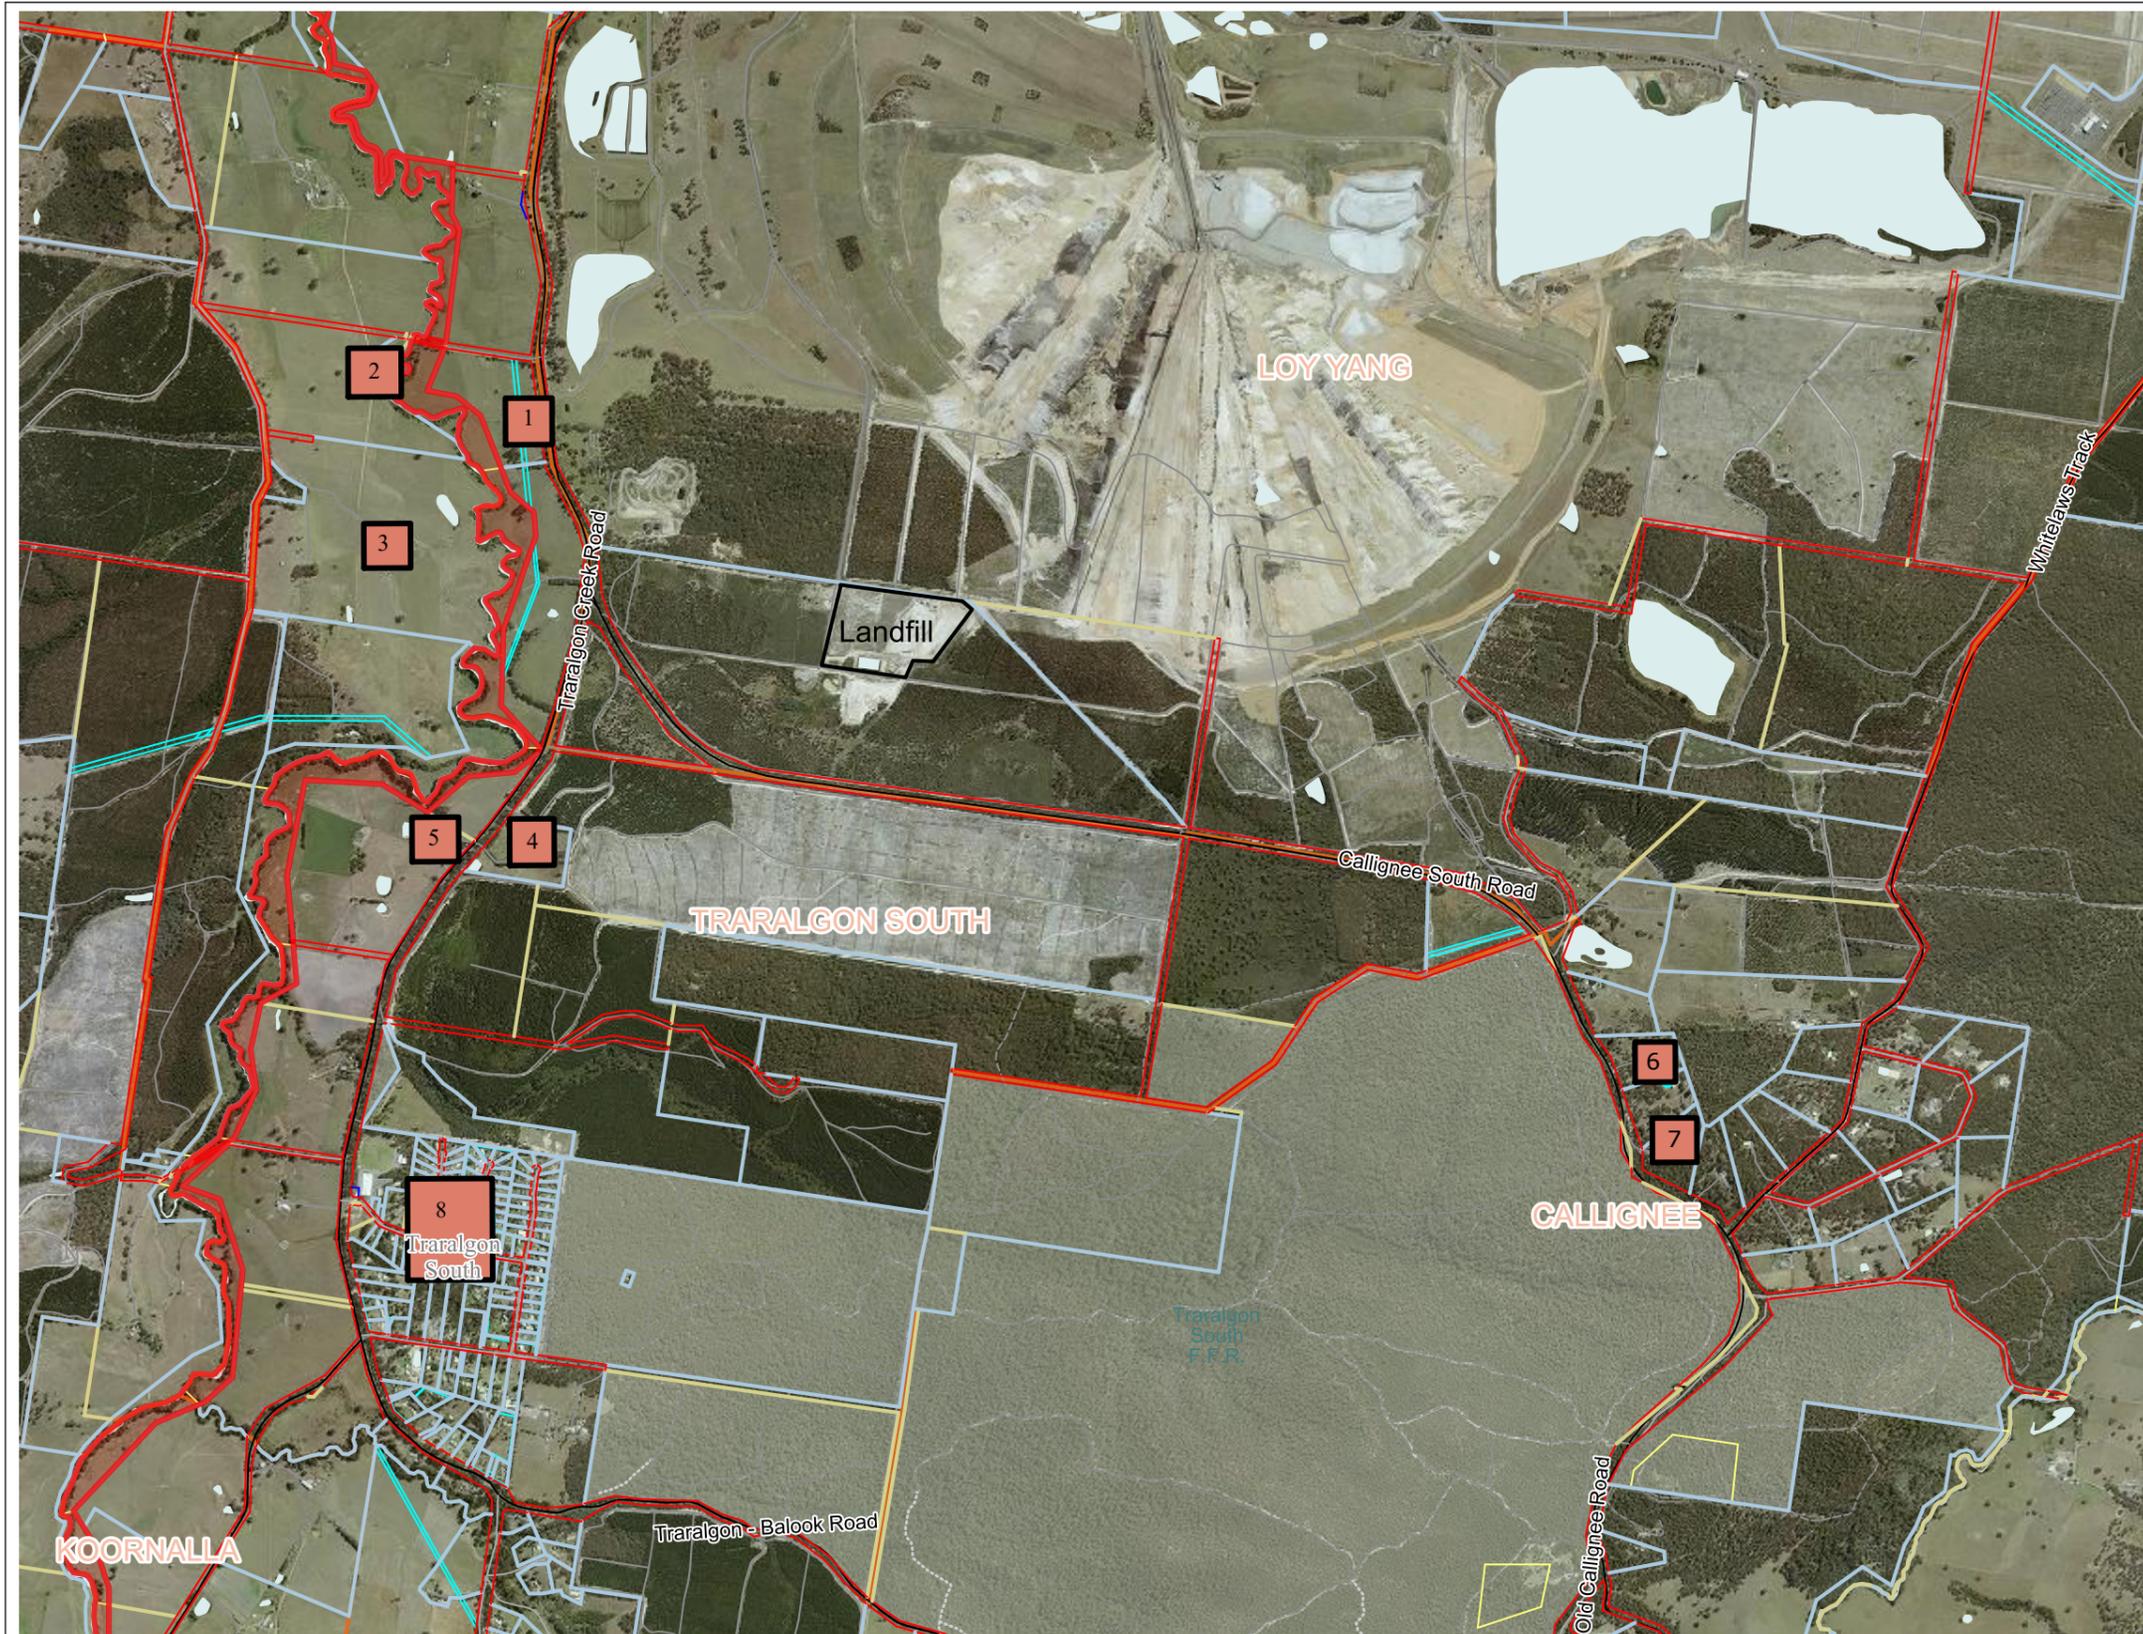
Distance From Landfill To the Residences

- 1. 1200 m
- 2. 1800 m
- 3. 1600 m
- 4. 1250 m
- 5. 1625 m
- 6. 3000 m
- 7. 3250 m
- 8. 2500 m
